Technical Note N-830

AIRFIELD PAVEMENT EVALUATION - USNAF CHINA LAKE, CALIFORNIA,

R. J. Lowe and W. H. Chamberlin,

July 1966

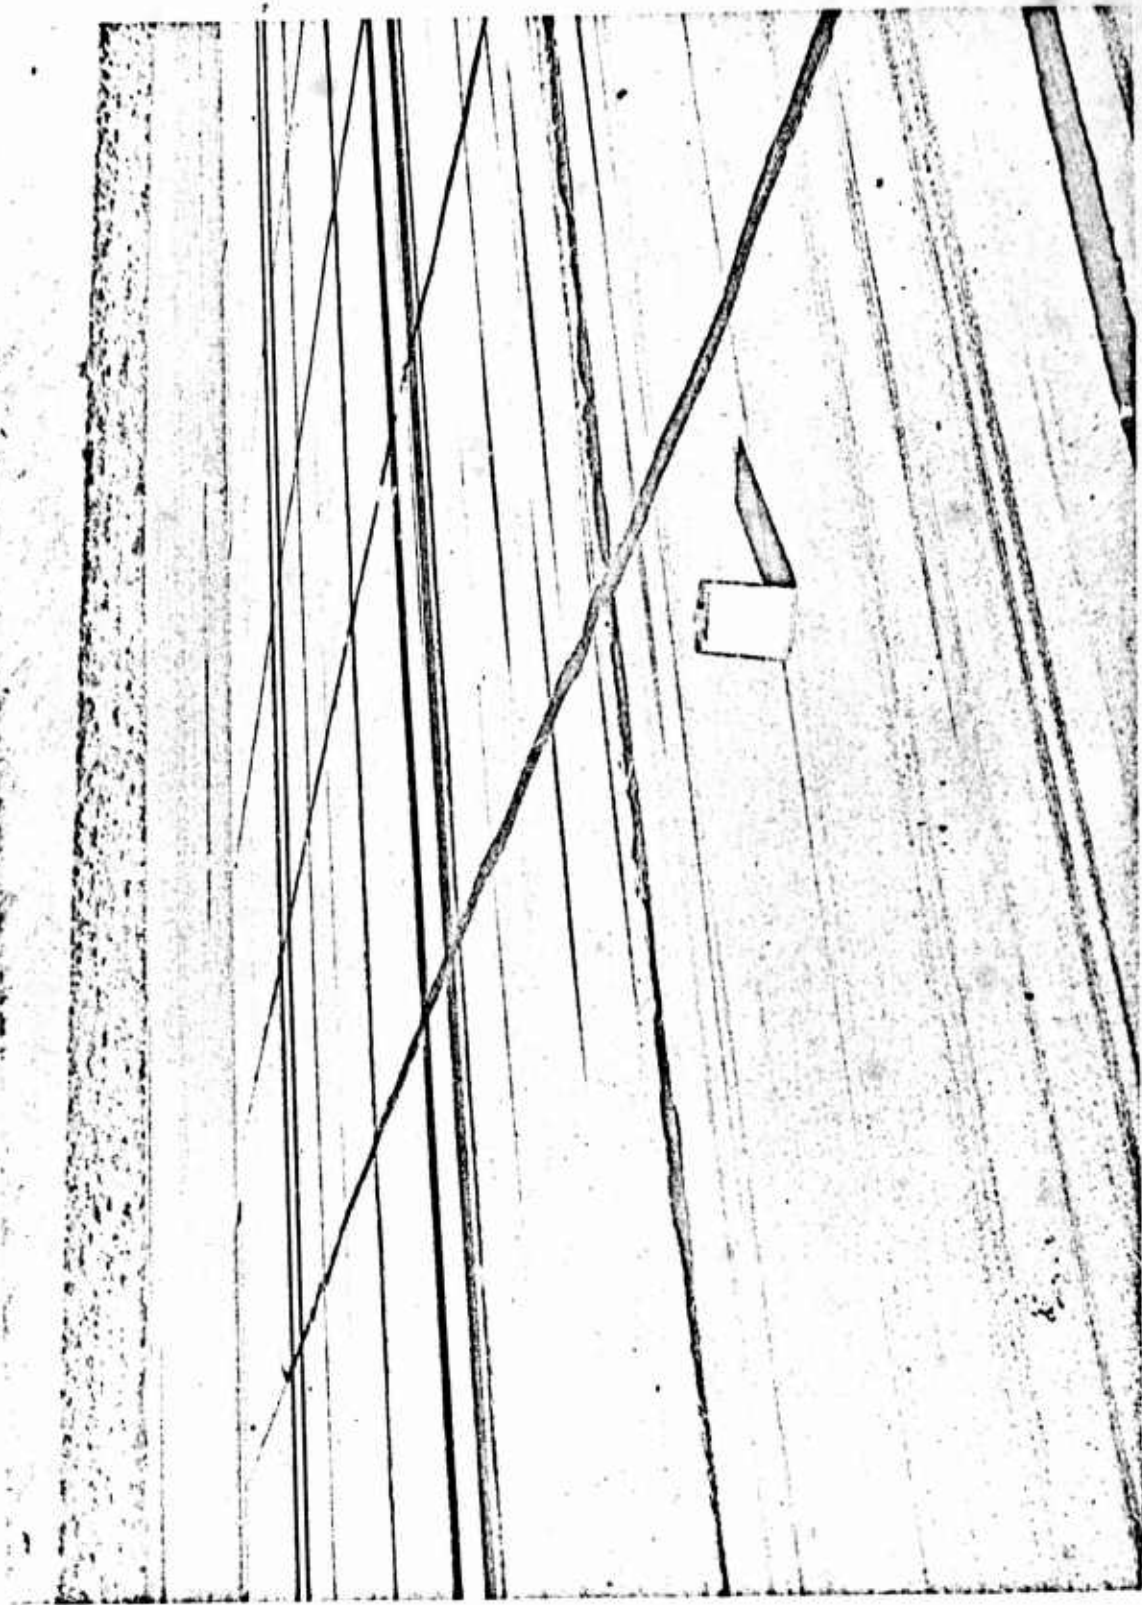
Figure 2. Surface defects in concrete on Runway 14-32, U. S. Naval Air Facility, China Lake, California.

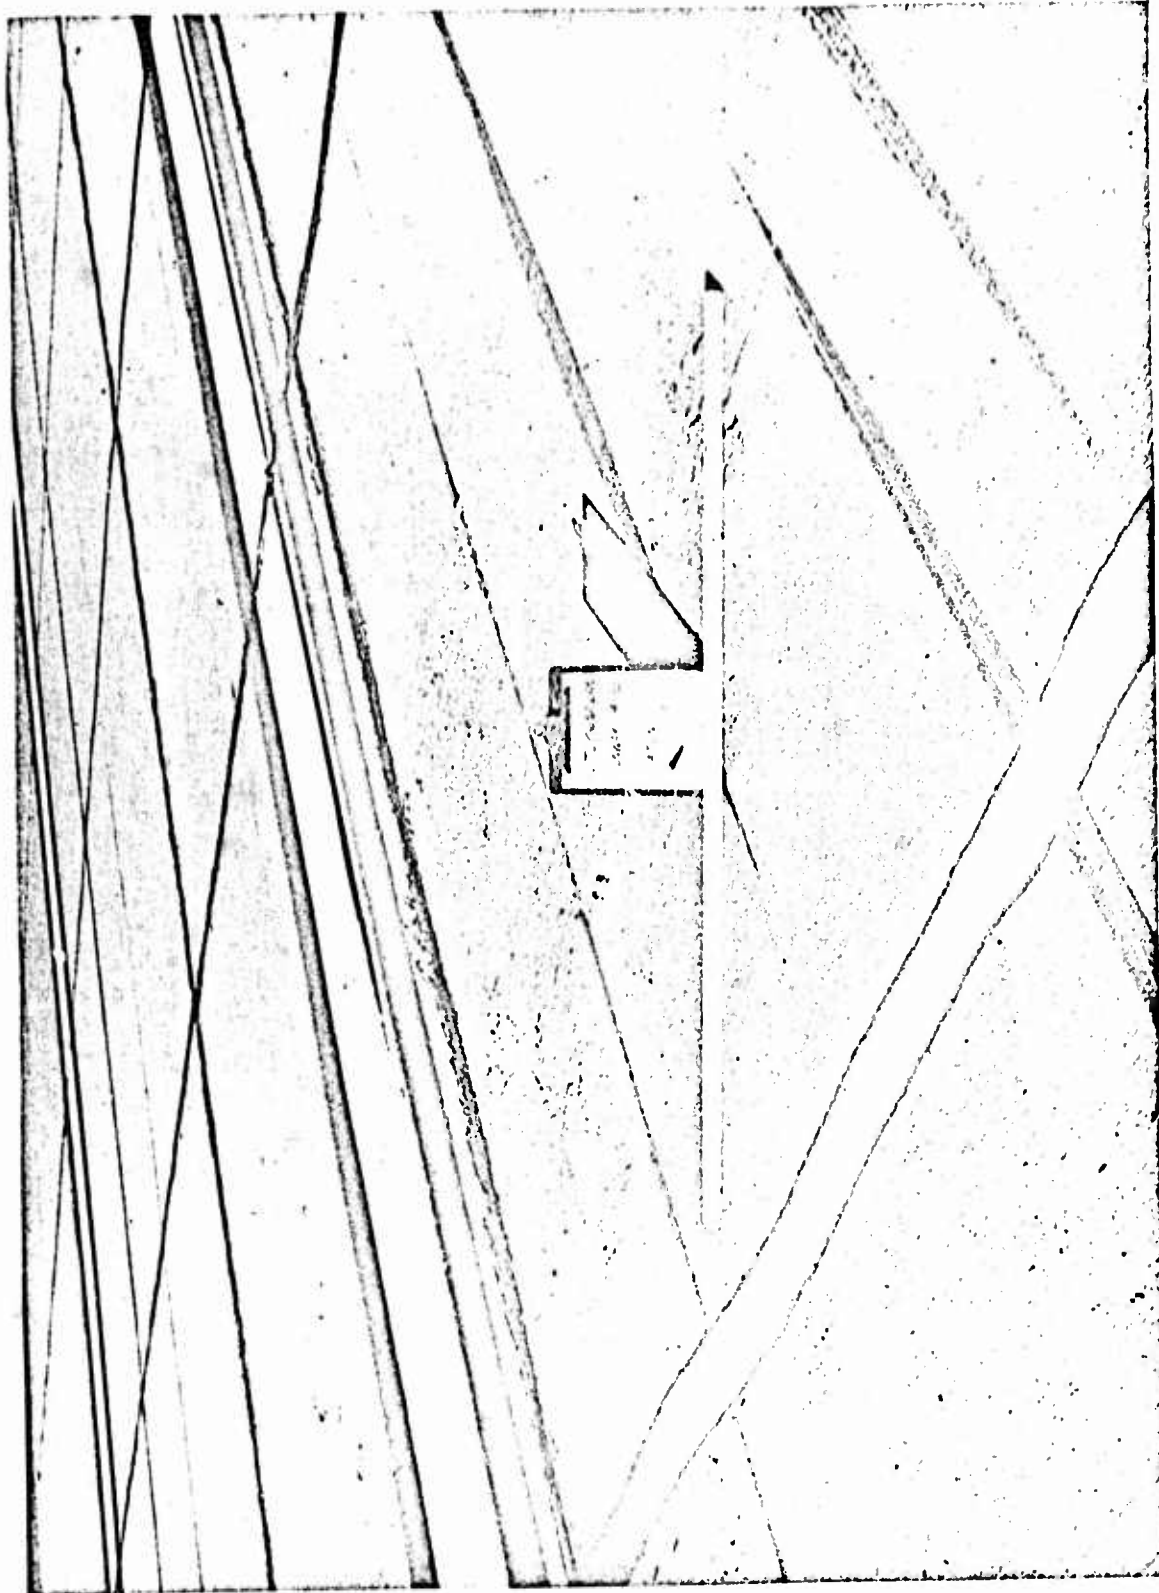
Figure 3. Close-up of concrete spill area of Runway 14-32, U. S. Naval Air Facility, China Lake, California.

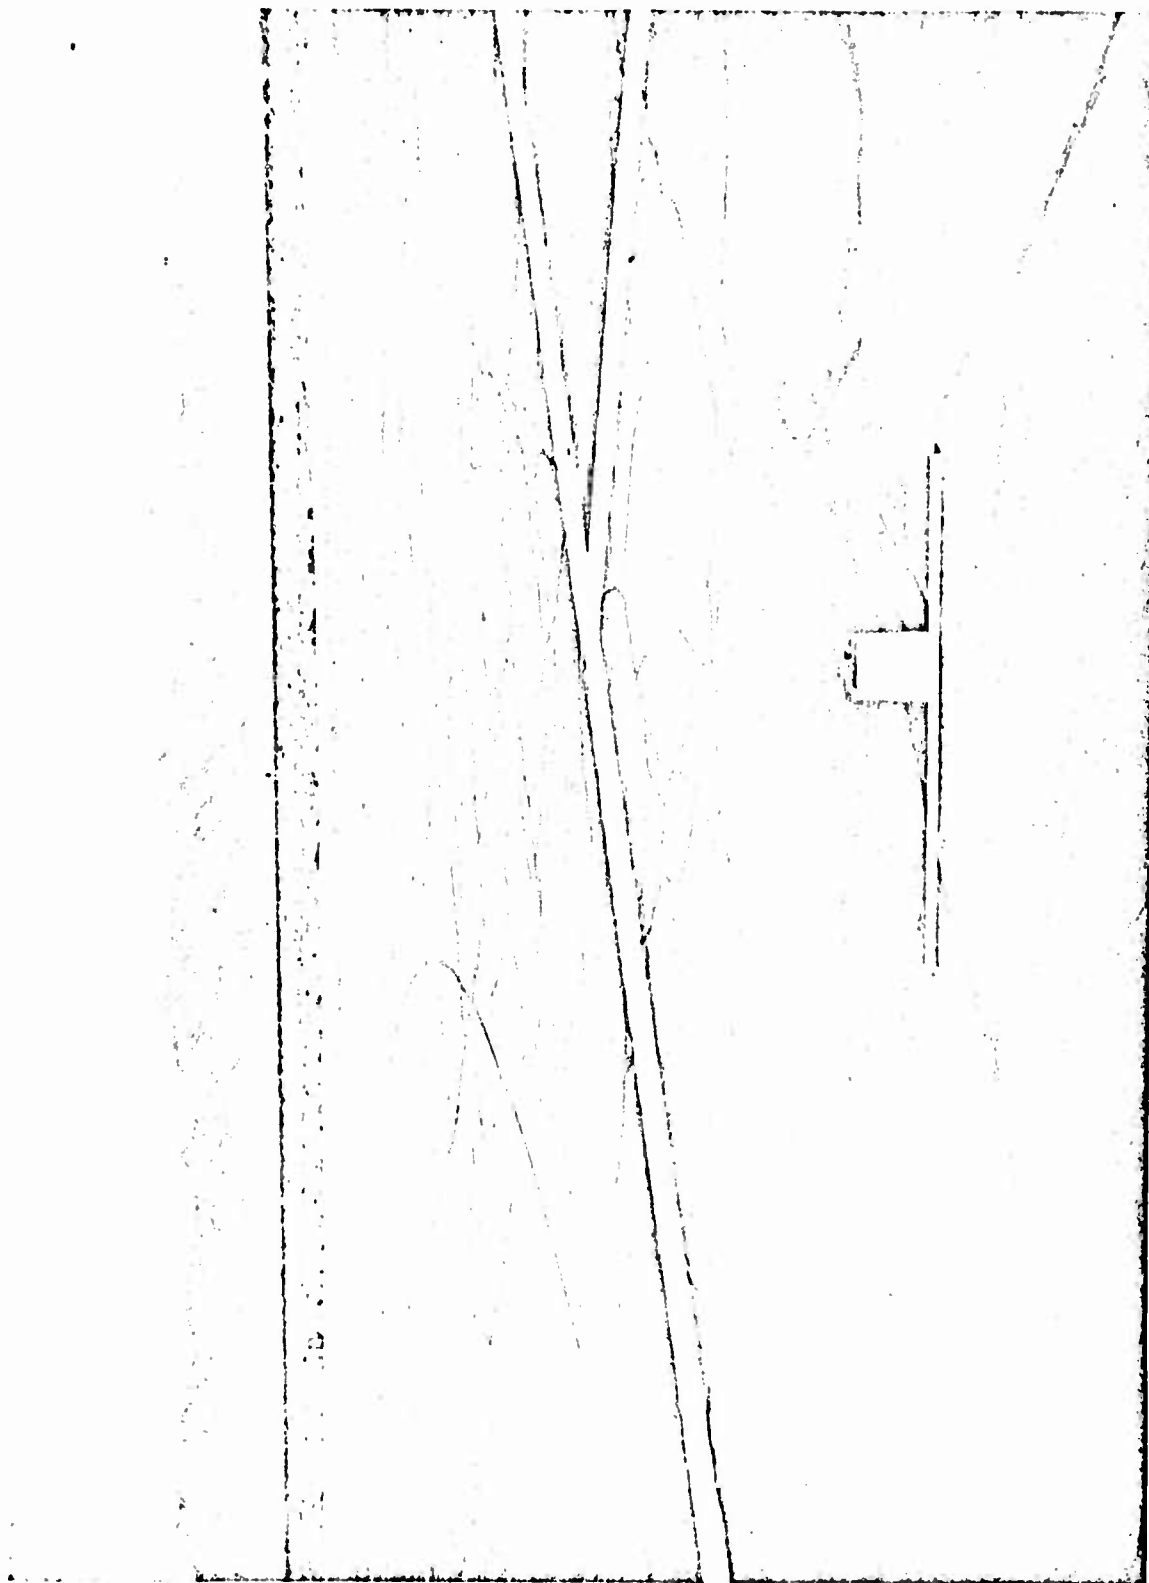
Figure 6. General view of Runway 14-32 at junction of Runway 3-21 showing poorly sealed longitudinal and transverse cracks. U. S. Naval Air Facility, China Lake, California.

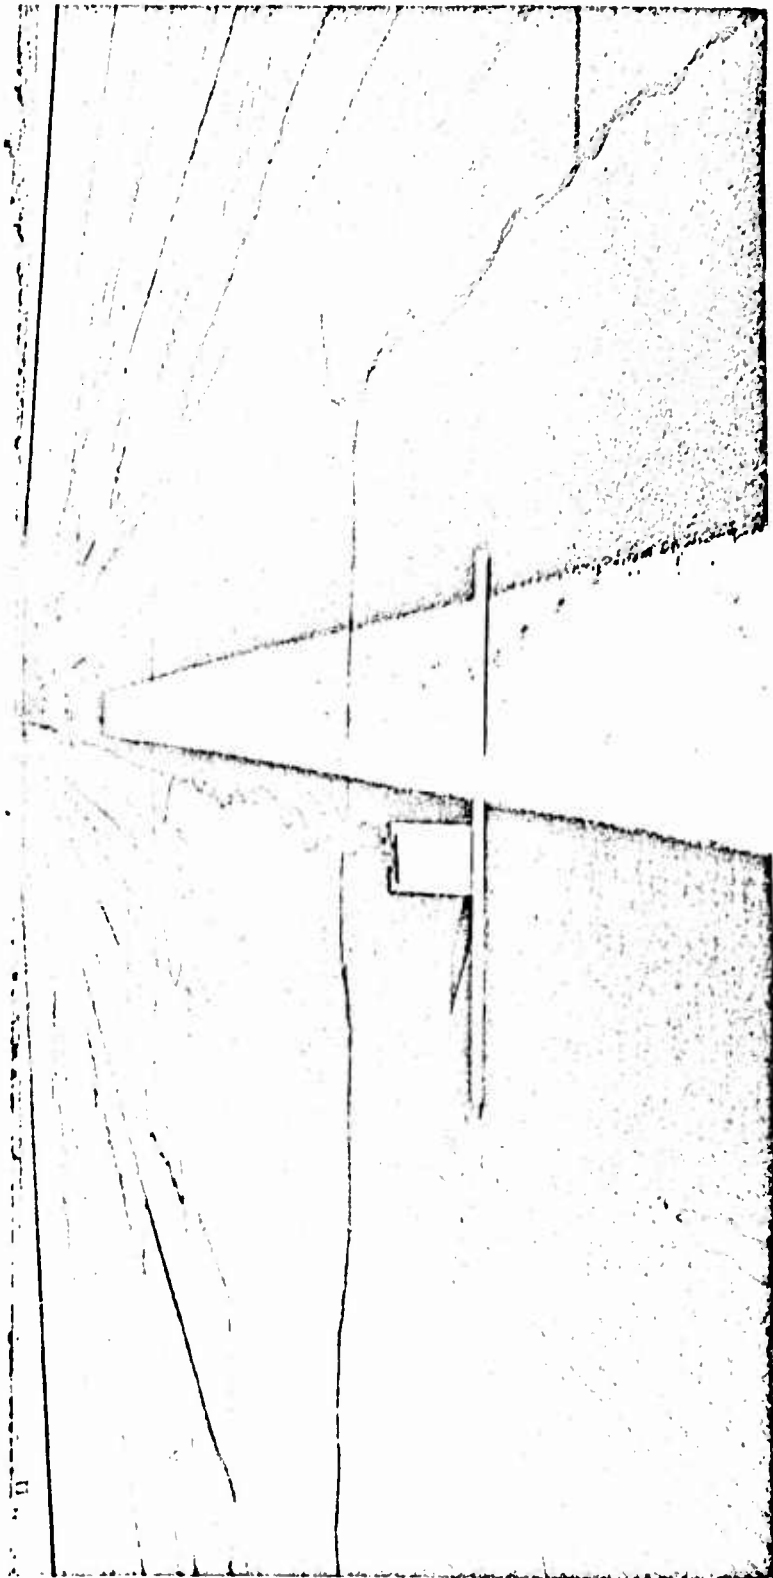
Figure 8. Longitudinal and transverse cracking in asphaltic concrete pavement, Runway 3-21, U. S. Naval Air Facility, China Lake, California.

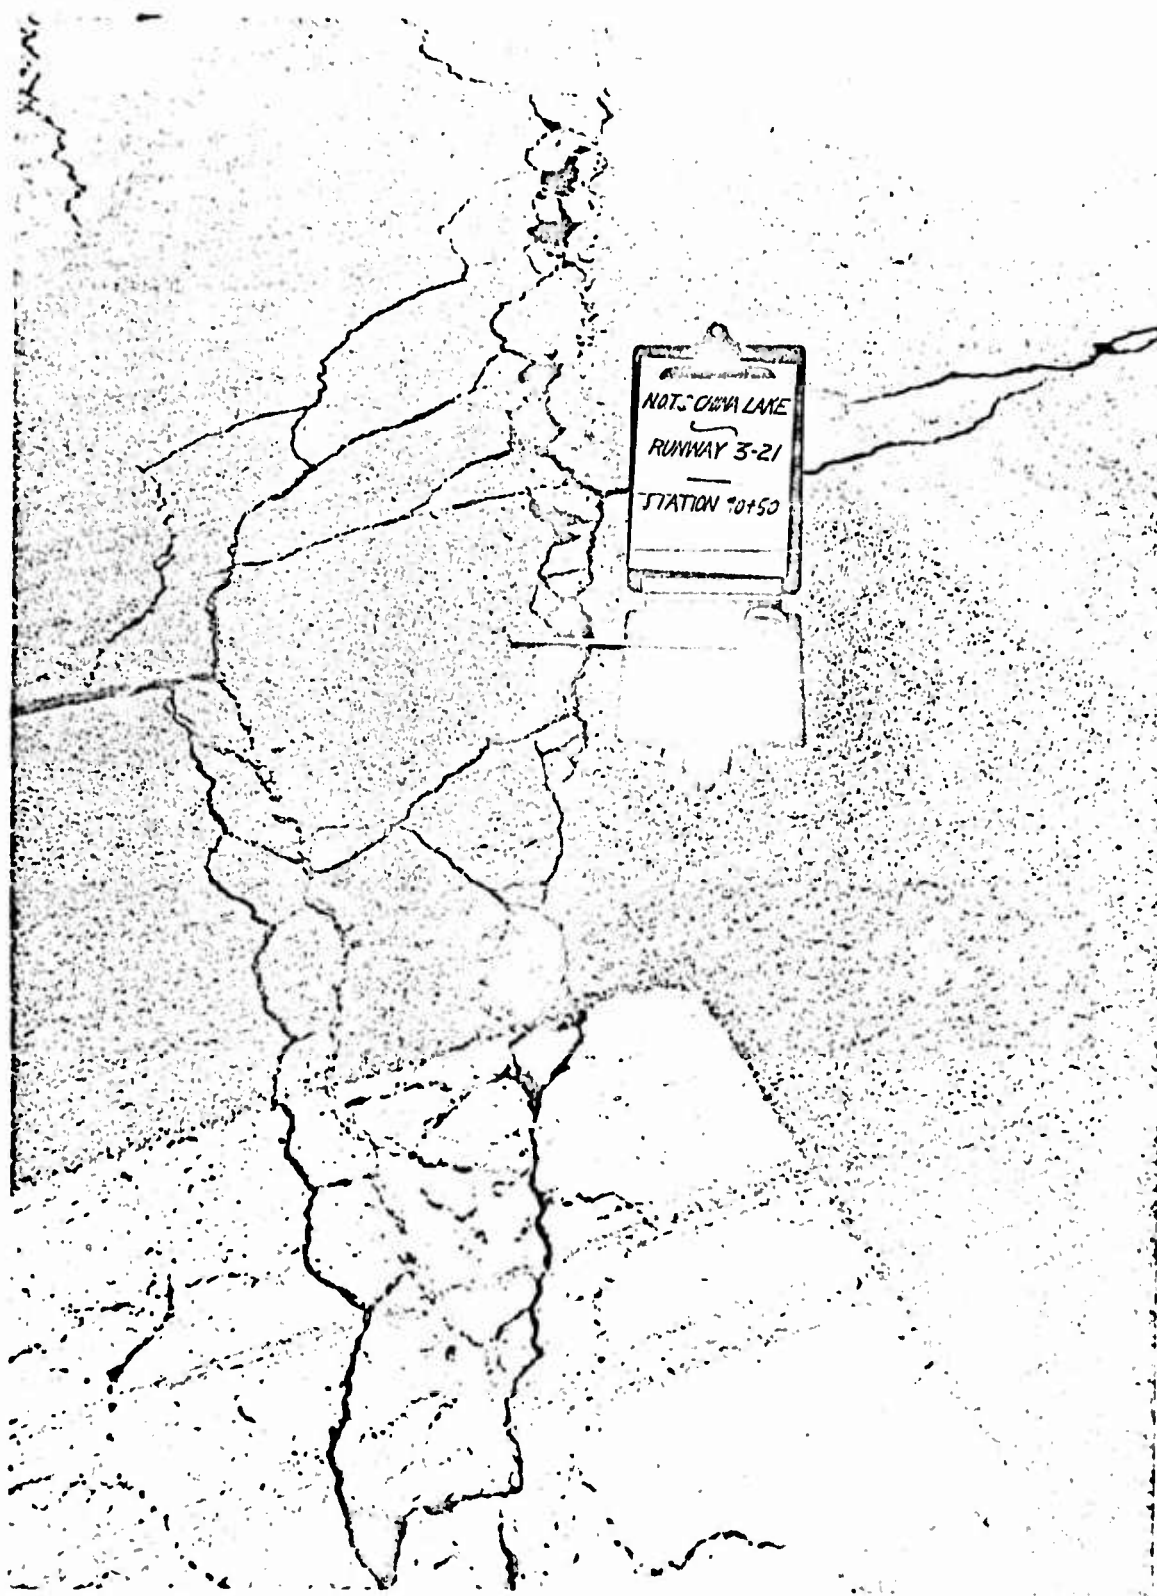
Figure 13. Severe cracking and spalling combined with raveling on Runway 3-21, U. S. Naval Air Facility, China Lake, California.

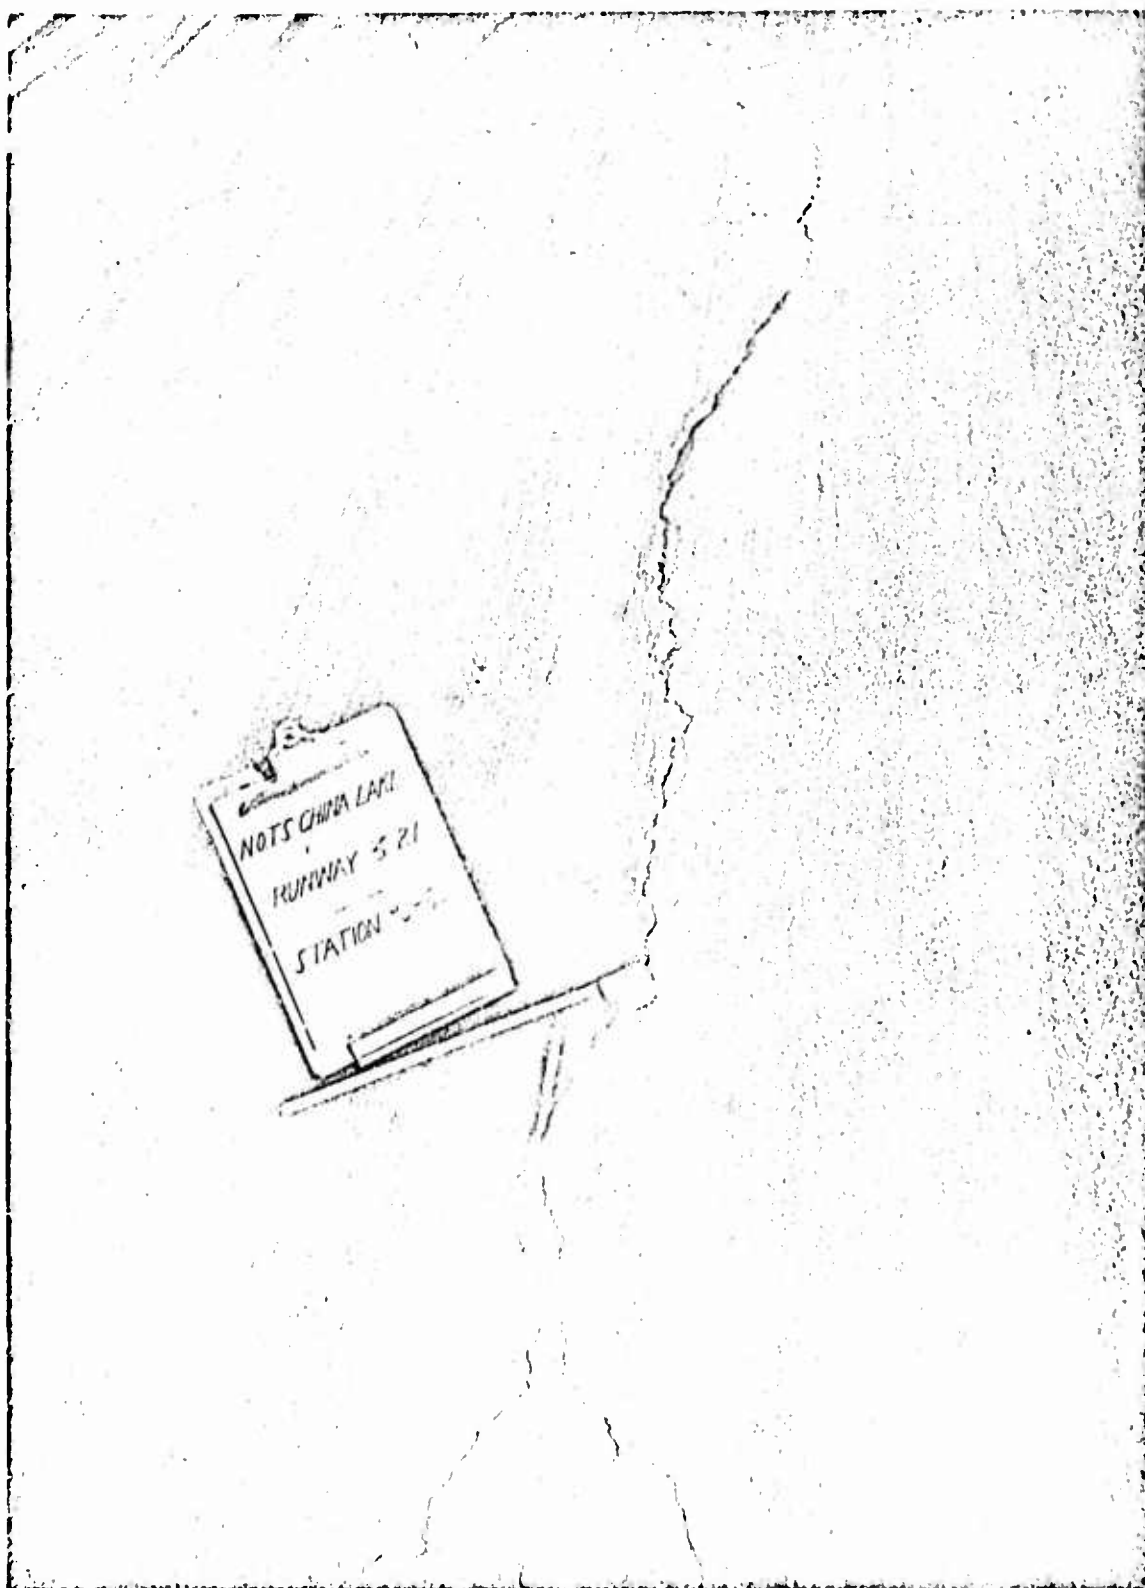
Figure 14. Close-up view of raveling along longitudinal crack on Runway 3-21, U. S. Naval Air Facility, China Lake, California.

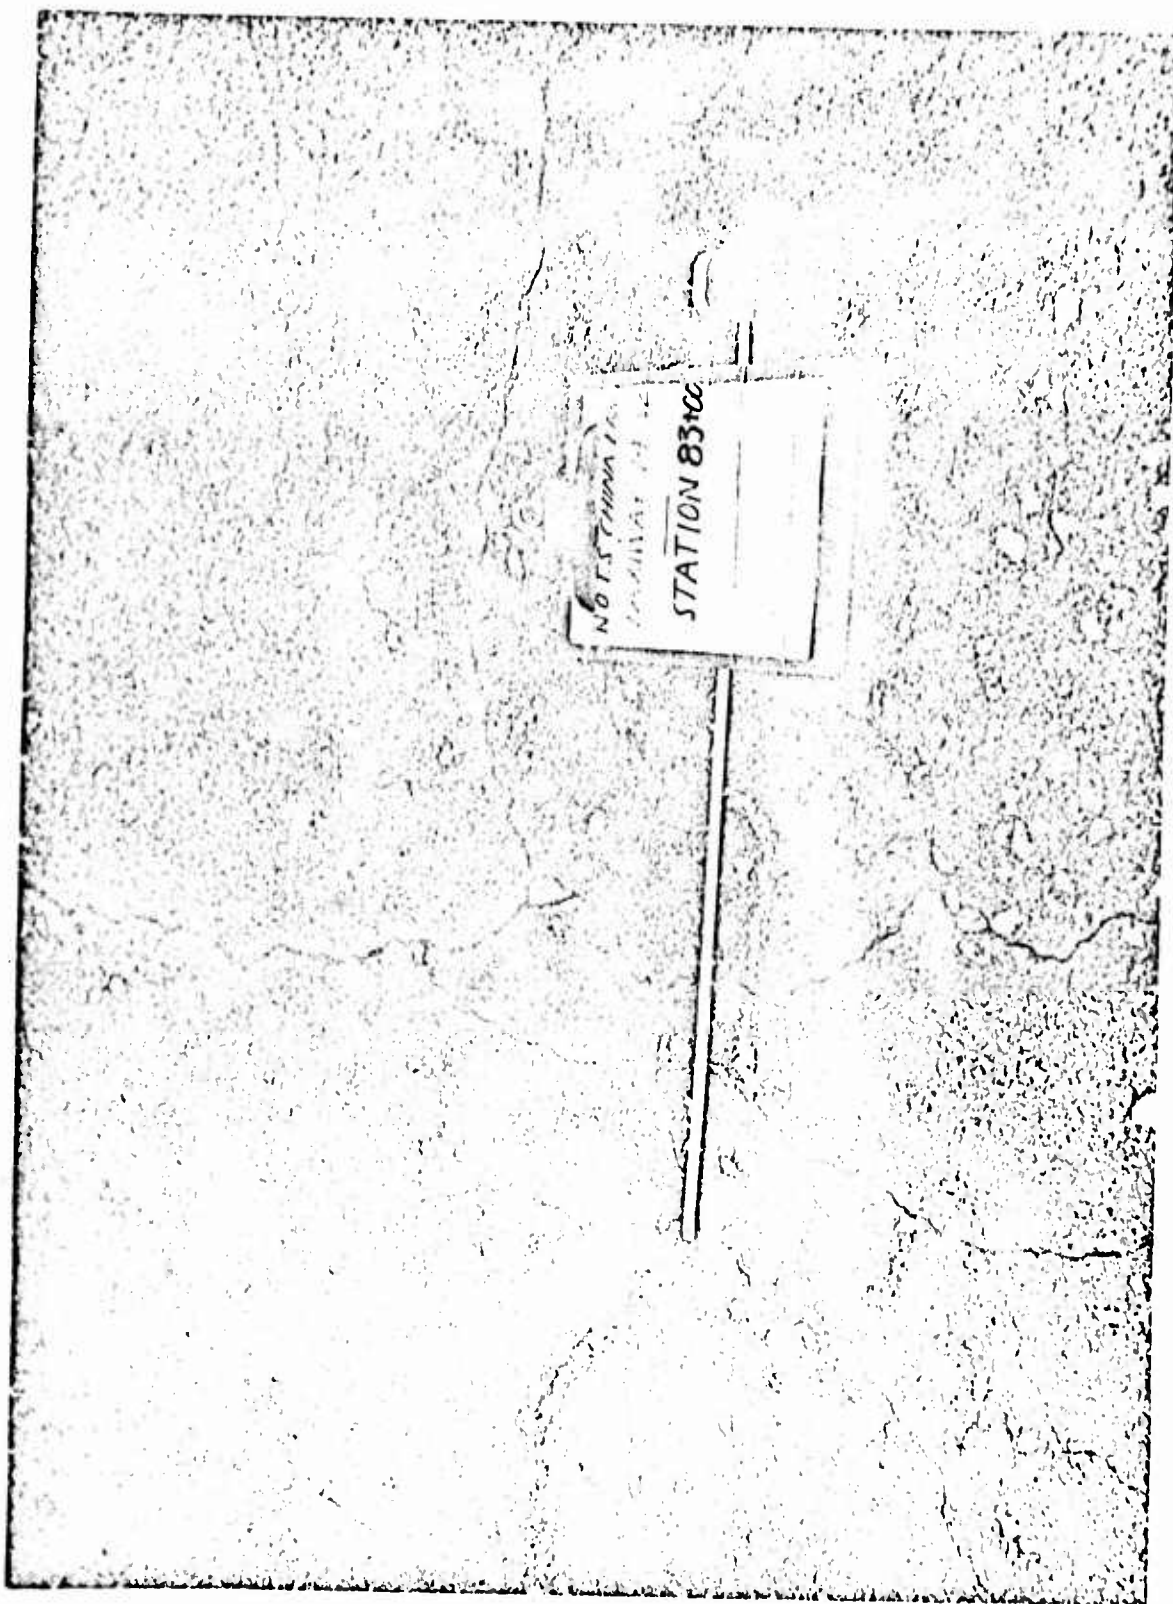
Figure 17. Close-up of surface deterioration on Taxiway 14-32, U. S. Naval Air Facility, China Lake, California.

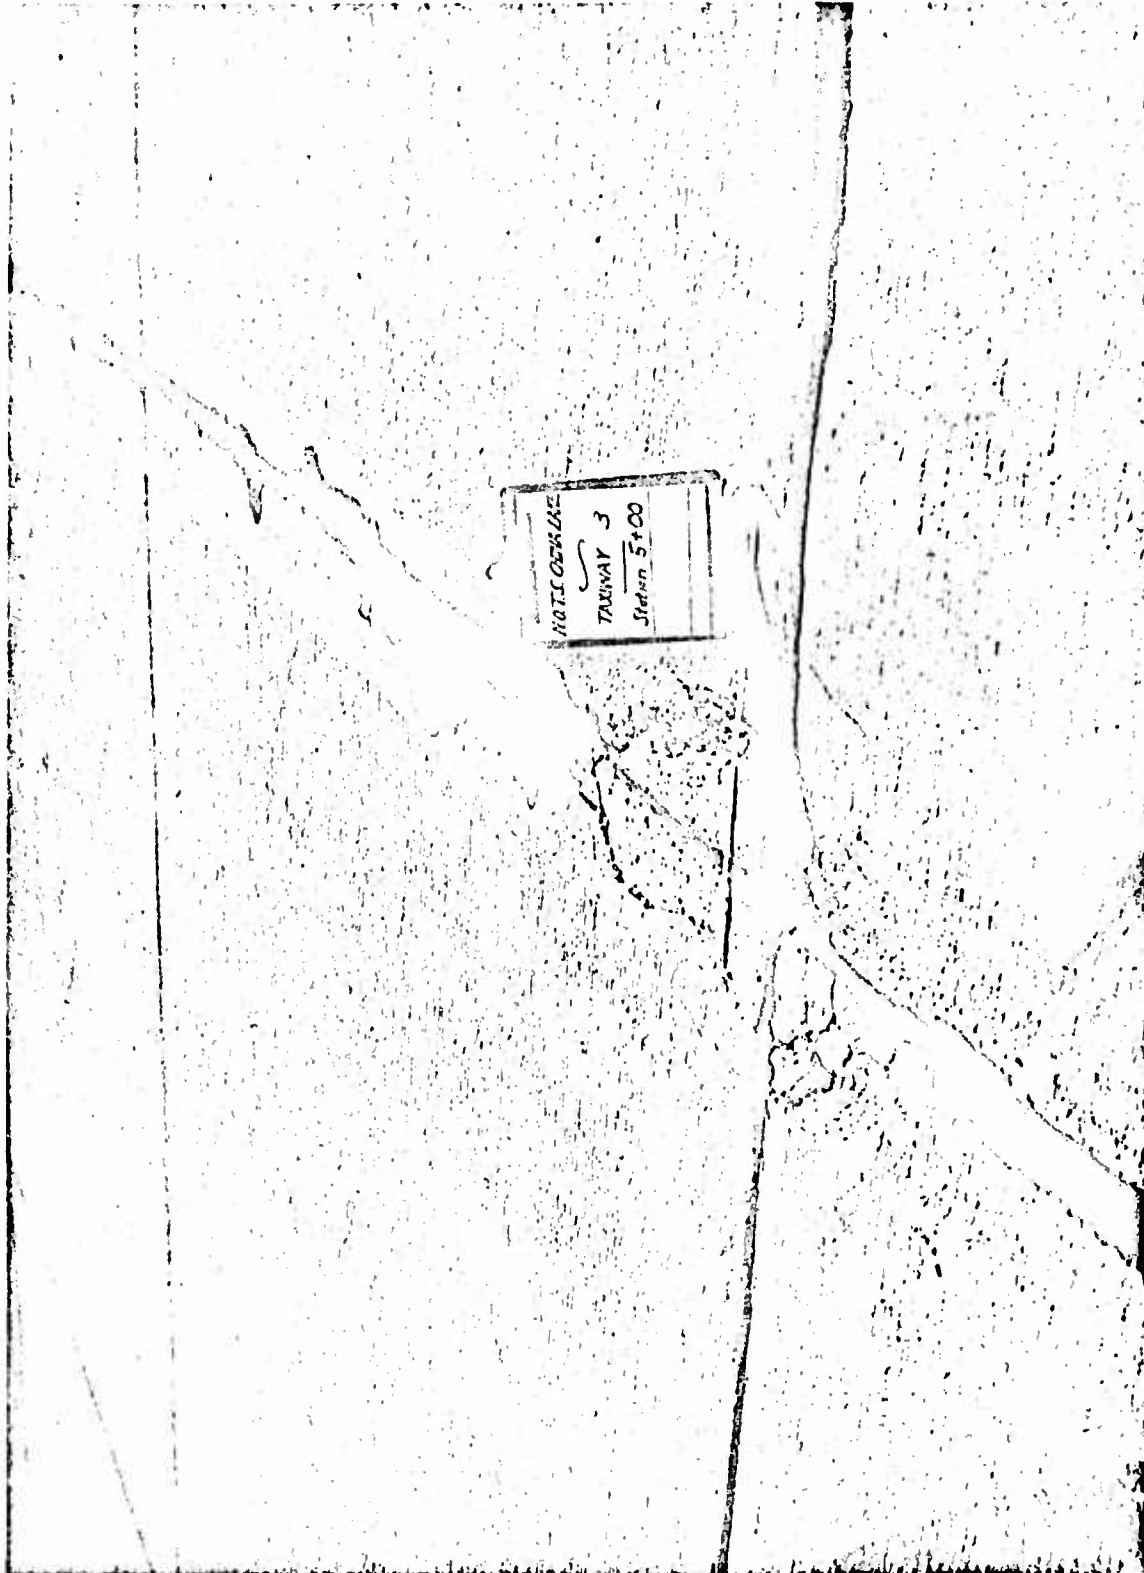
Figure 18. Poor portland cement concrete corner patch with additional cracking and spalling on Taxiway 3, U. S. Naval Air Facility, China Lake, California.

Occasional small corner break. Some cracking parallel to transverse joints. Occasional joint spalling to 5-inch width. Only repairs in evidence is resealing of joints to cover spalled areas. Minor surface popouts. See Figure 18.

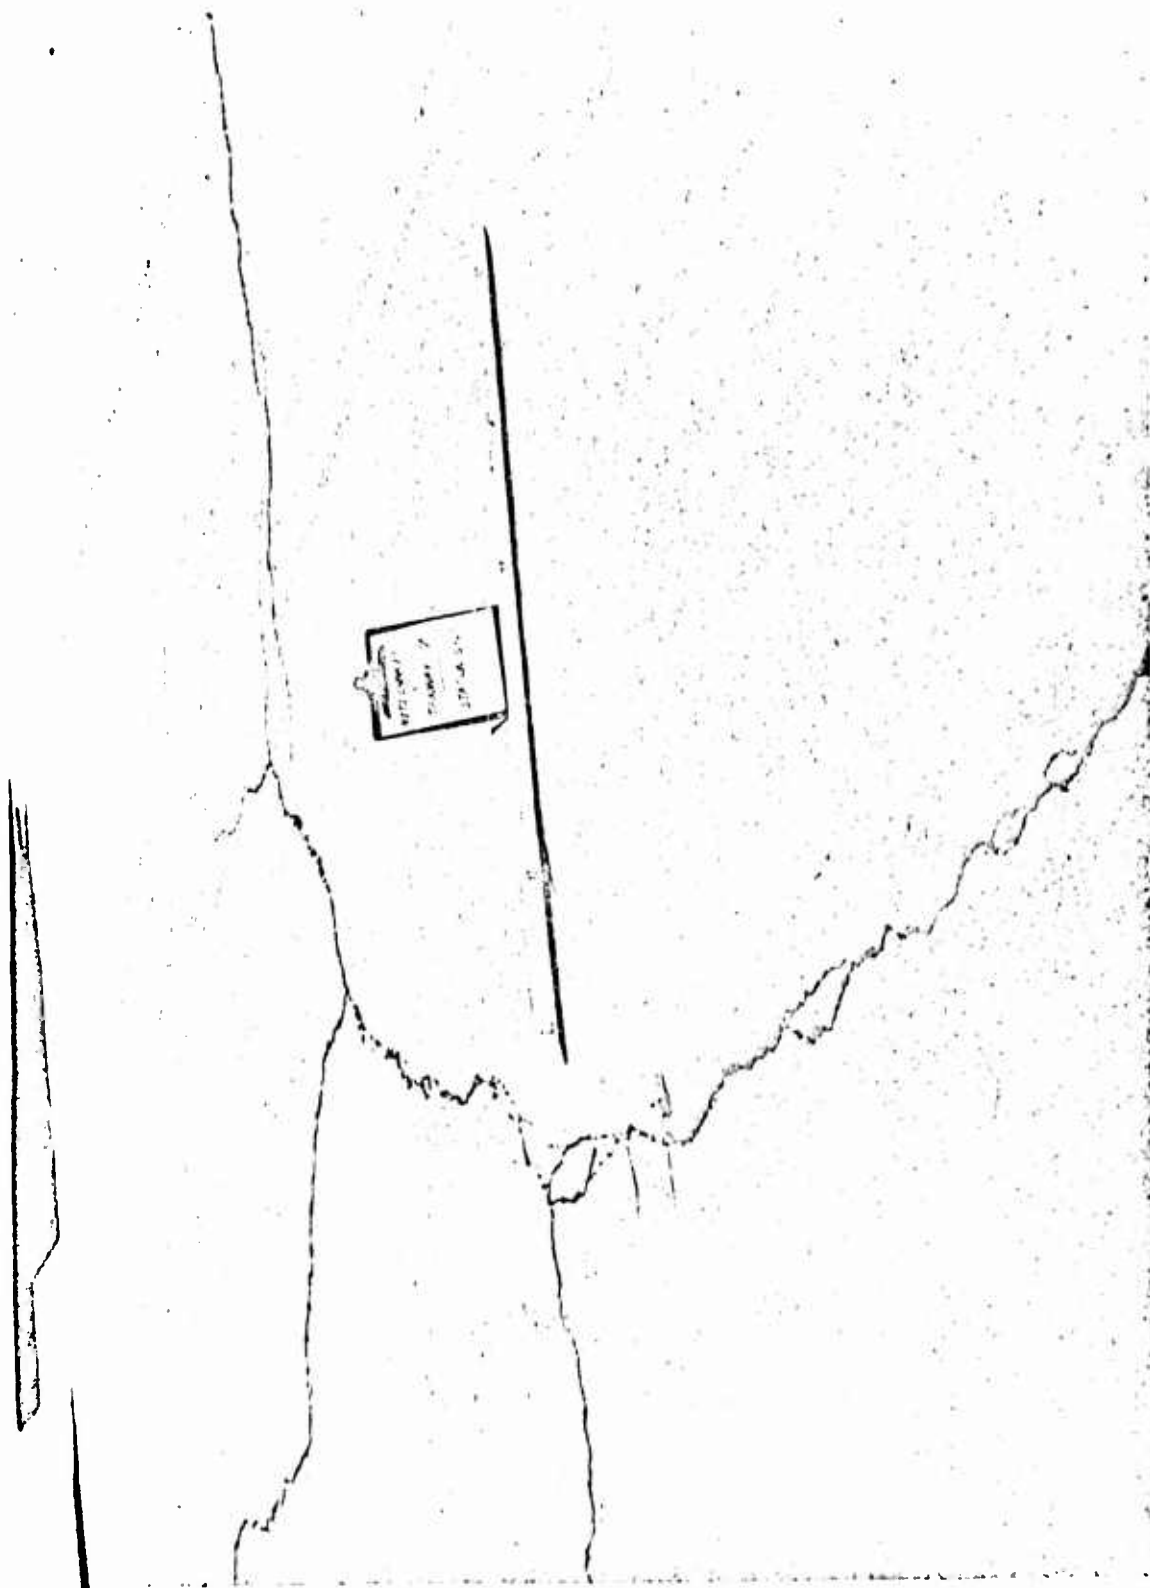
Figure 20. Severe longitudinal, diagonal, and transverse cracking and raveling on Taxiway 7, U. S. Naval Air Facility, China Lake, California.

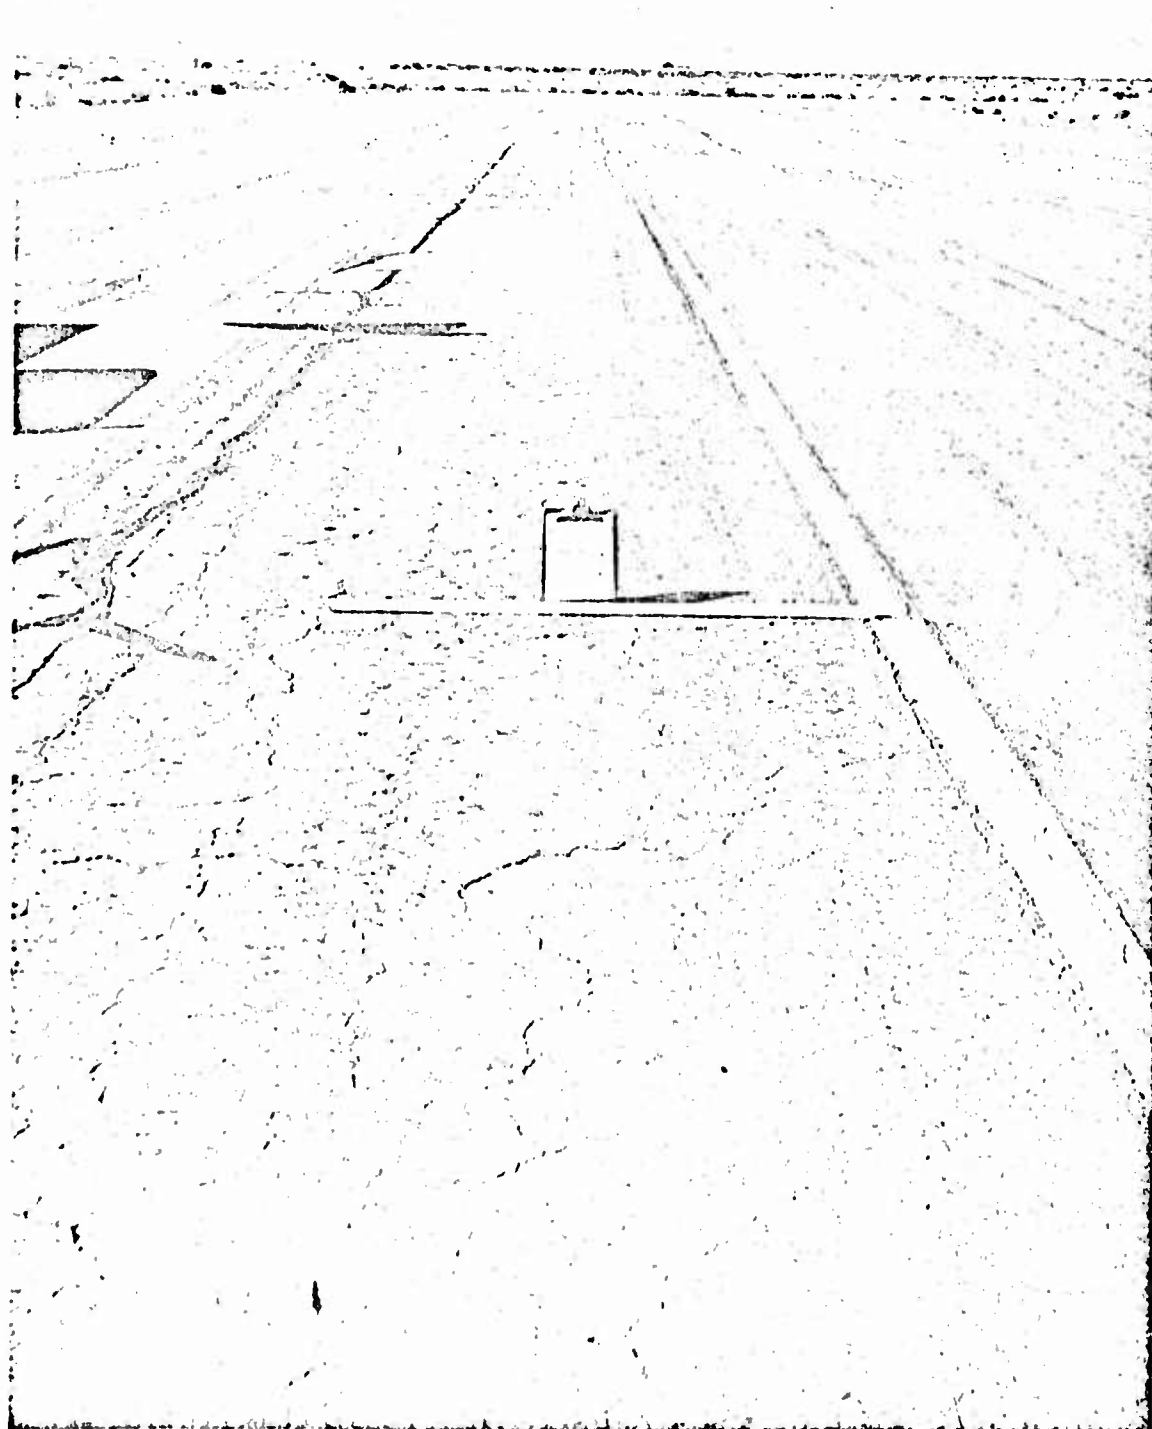
Figure 23. General view of Taxiway 25 showing various types of cracks and rutting. U. S. Naval Air Facility, China Lake, California. 63

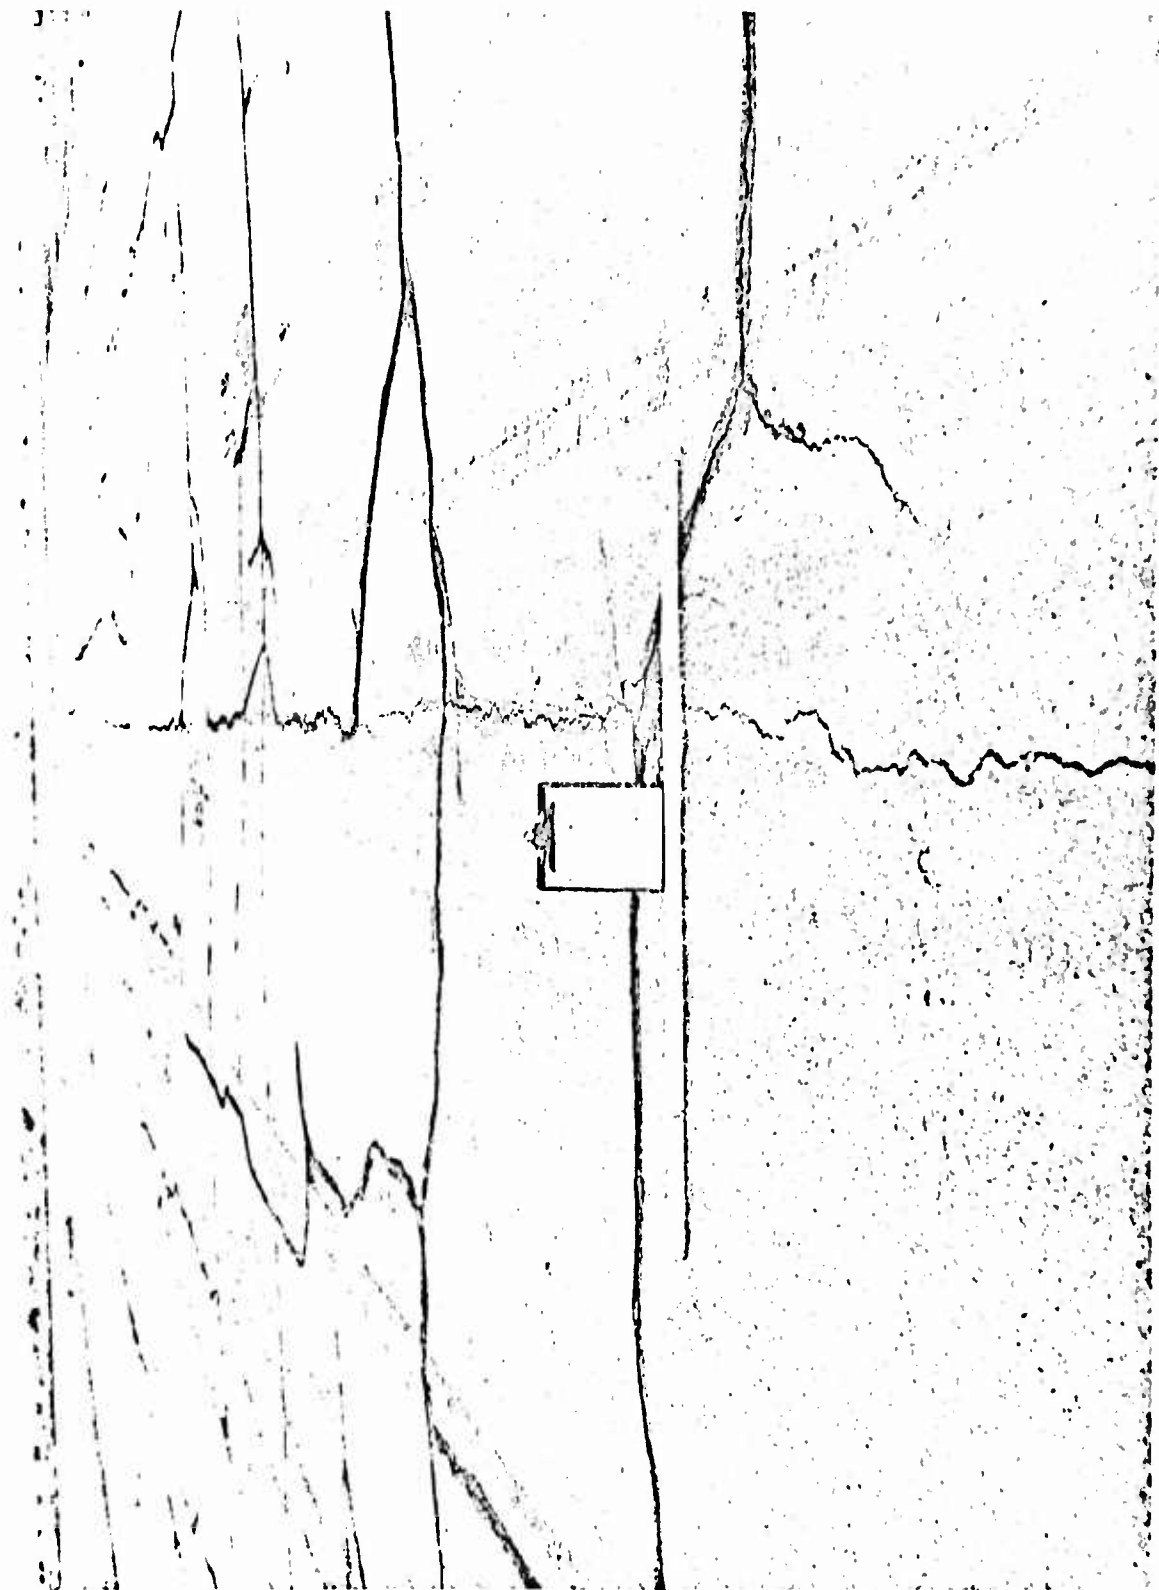
Figure 24. General view of Connecting Taxiway A showing severe crack patterns, U. S. Naval Air Facility, China Lake, California.

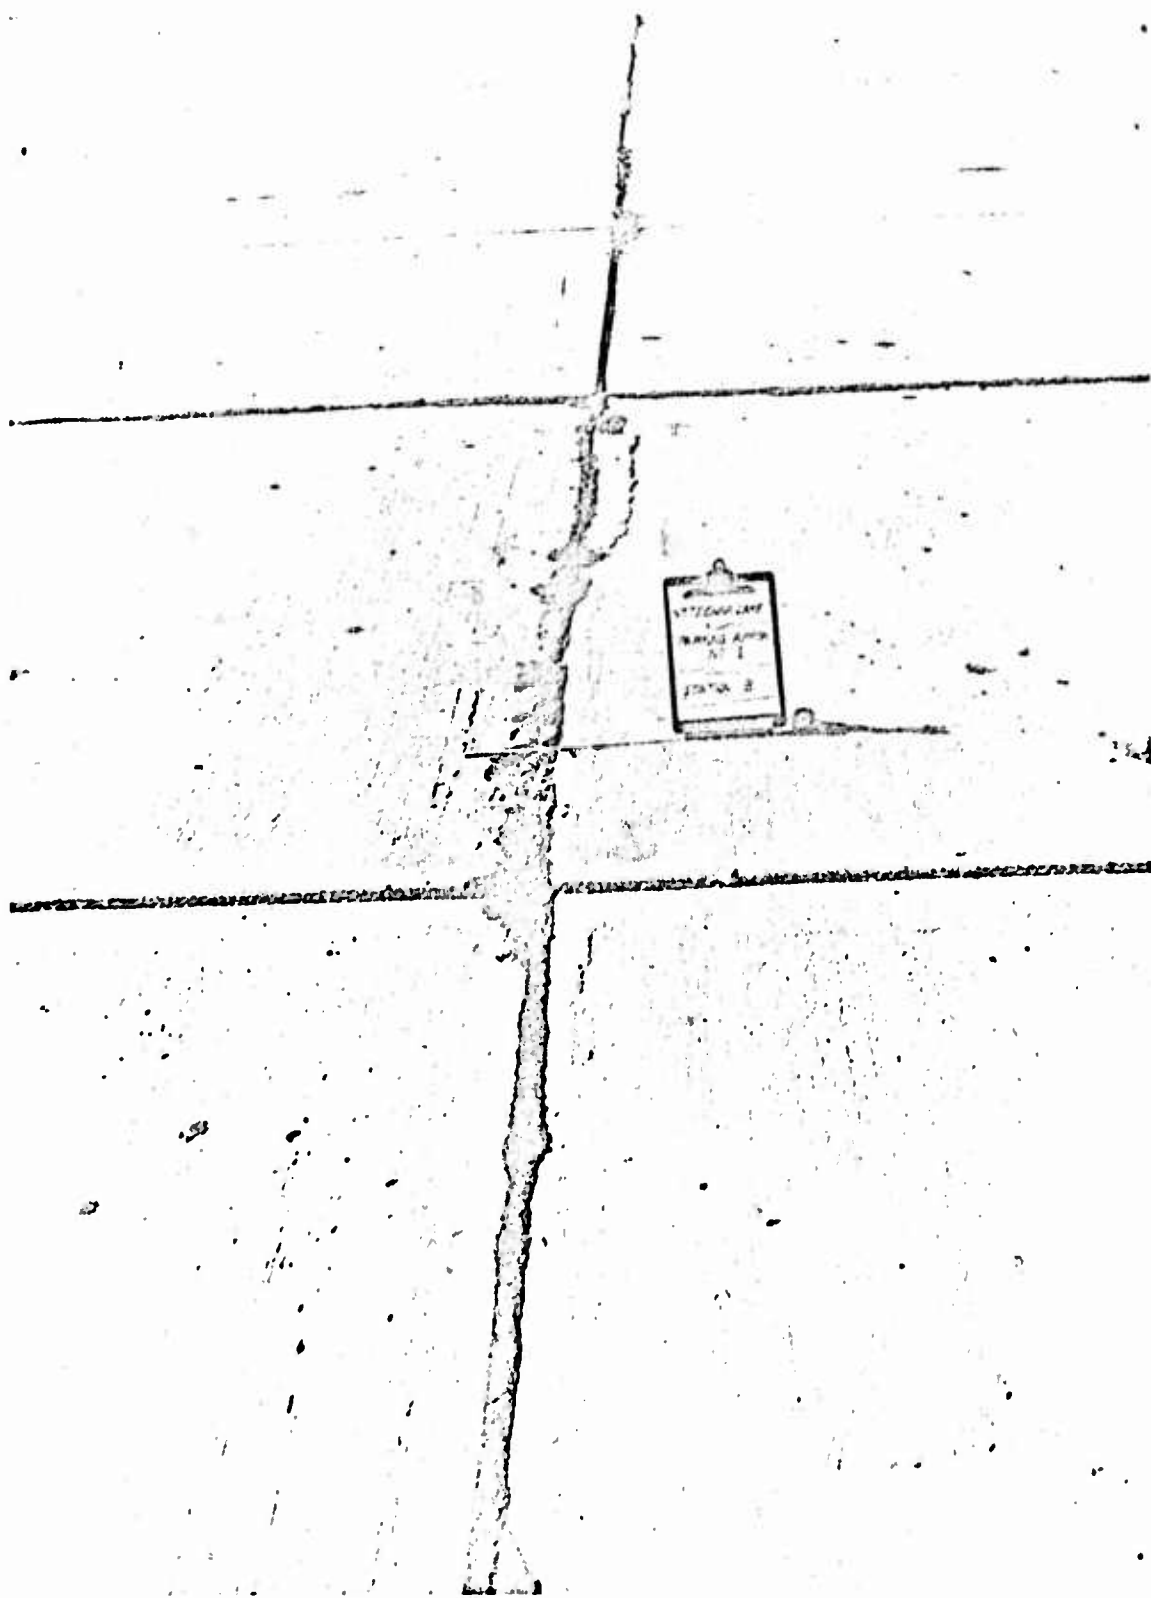
Figure 25. Longitudinal joint spall and patches on Parking Apron 1. The spall appears to have been a patch. U. S. Naval Air Facility, China Lake, California.
